Performance of Lightly Reinforced Concrete Intake Towers Under Selected Loadings

by Richard Charles Dove

Final report

284 p.: ill.; 28 cm. — (Technical report; SL-98-1)

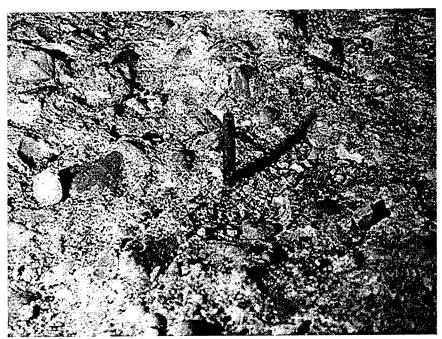
Figure 80. ITS-2, typical failed reinforcing bar.
